COMPOSITE JOIST PROJECT

SPONSORED BY STEEL JOIST INSTITUTE

INTERPRETATION OF COMPOSITE JOIST TEST RESULTS

September 1967

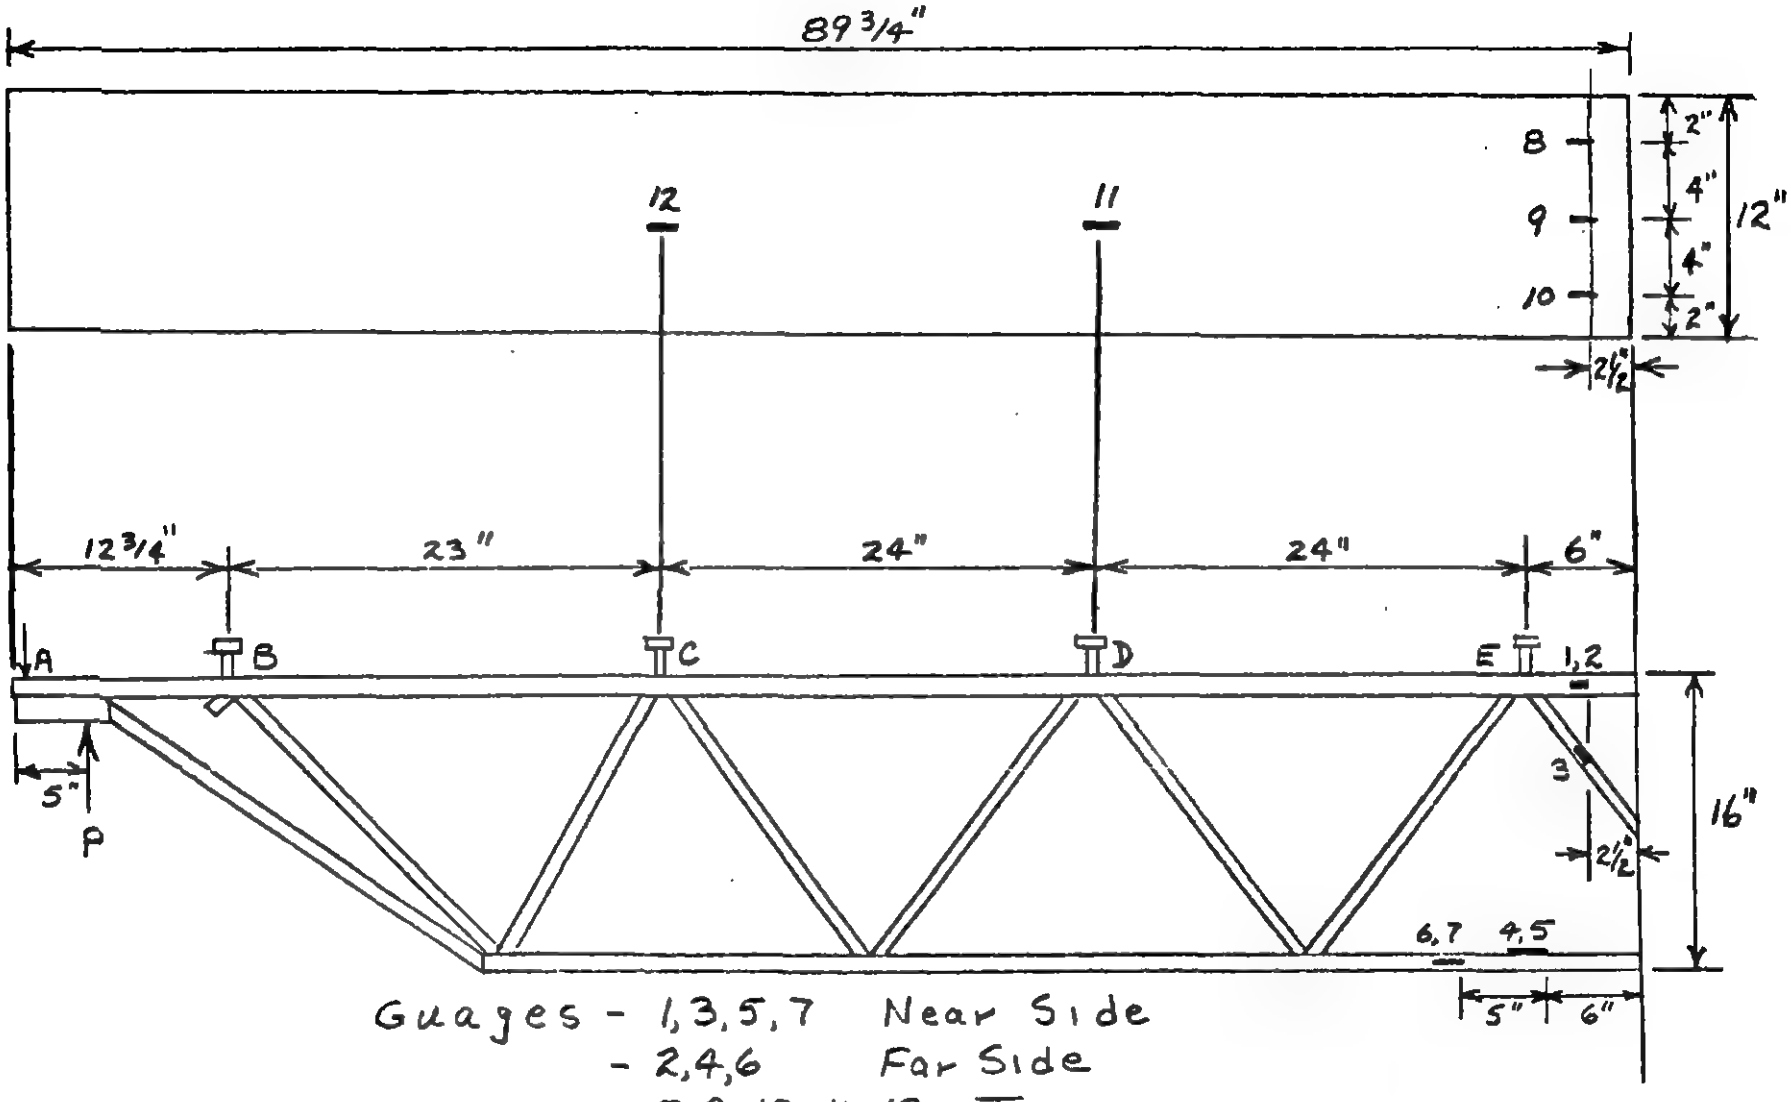
FIG 3a Test Joist C1a

4.1.1 C1a - After several load increments separation was noticed between the concrete and the compression chord at the last shear connector. Then a tension crack developed at the last shear connector and eventually extended nearly to the top of the slab. As the maximum load was obtained a load report was heard, which later inspection revealed was caused by the failure of the first three shear connectors. The loading was continued until the compression chord buckled.

The failure was attributed to yielding of the tension chord, followed by the failure of three of the shear connectors and then the buckling of the compression chord.

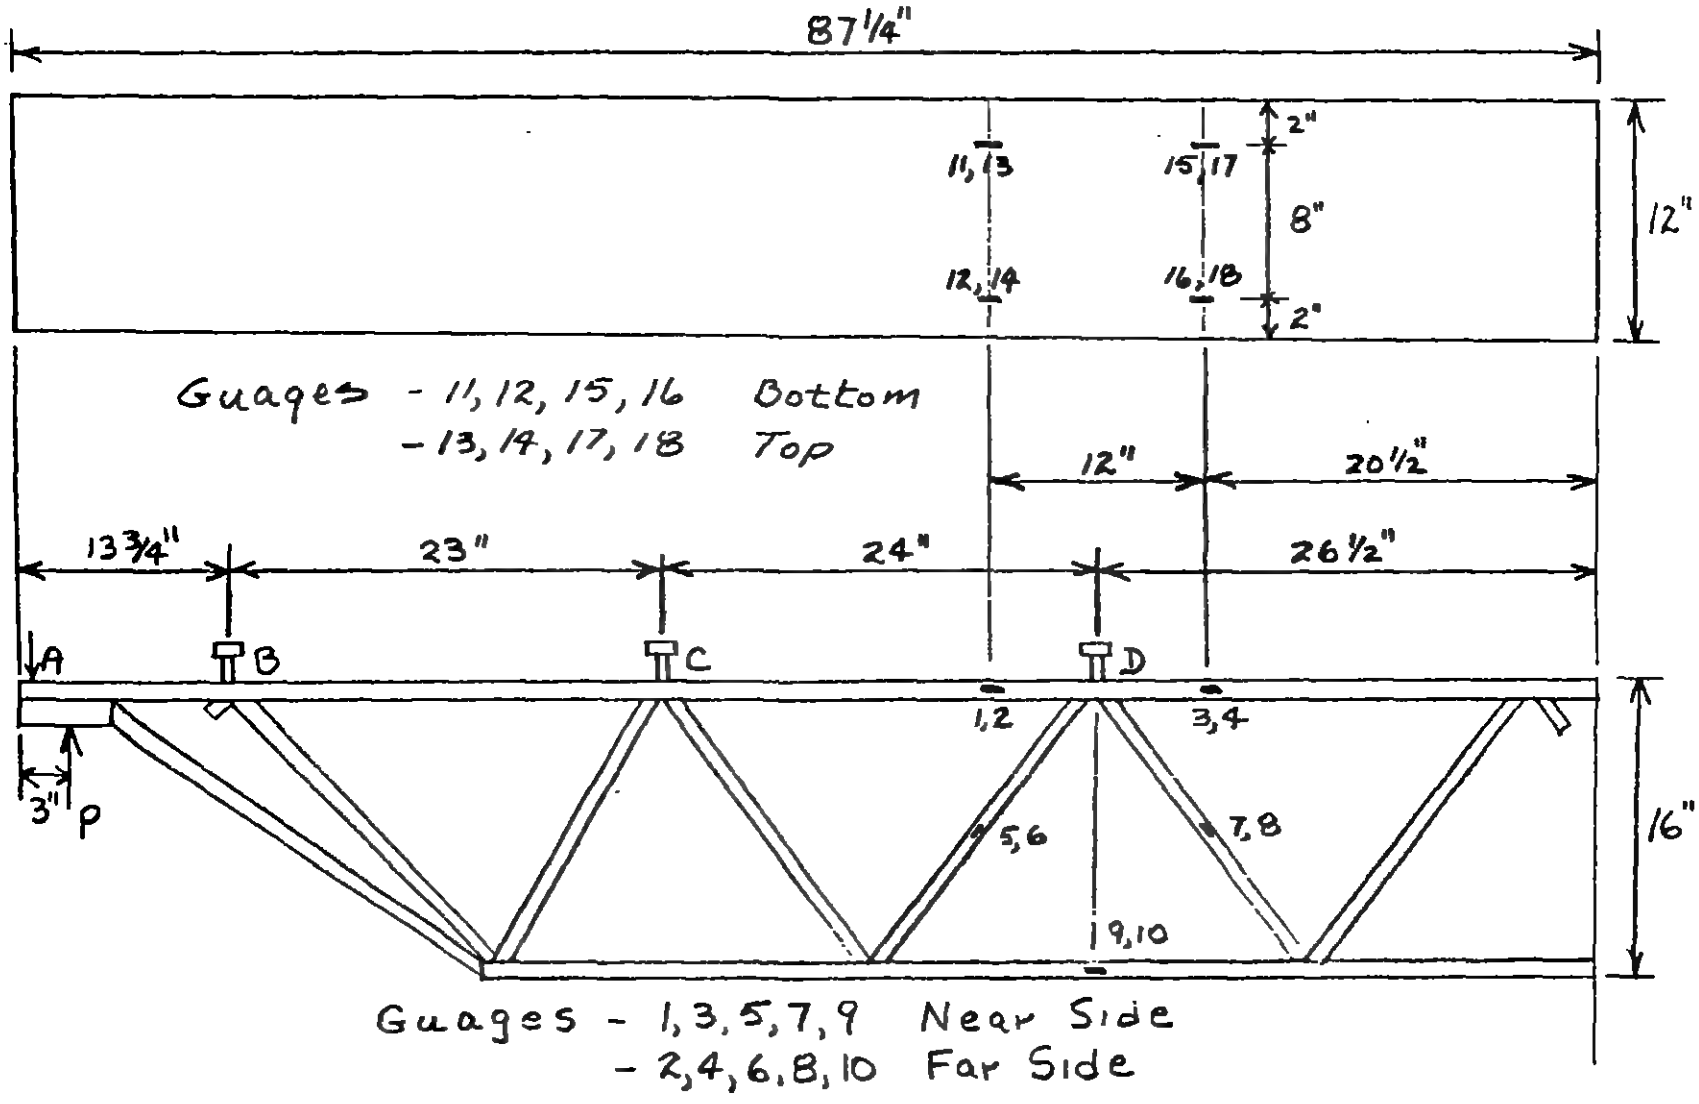
FIG 3b Test Joist C1b

4.1.2 C1b - The load was applied to the cantilever in increments until a weld failed. The load was removed, the weld was repaired since no damage was done before the failure occurred.

The first cracks between the slab and compression chord were noticed as the load approached that making the tension chord yield. The next load increments resulted in the yielding of the tension chord and considerable separation of the slab and compression chord at the last shear connection. The compression chord at the last shear connector began to buckle, a loud report occurred, indicating the failure of the shear connectors.

The failure occurred due to the yielding of the tension chord, the buckling of the compression chord and then the failure of the shear connectors.

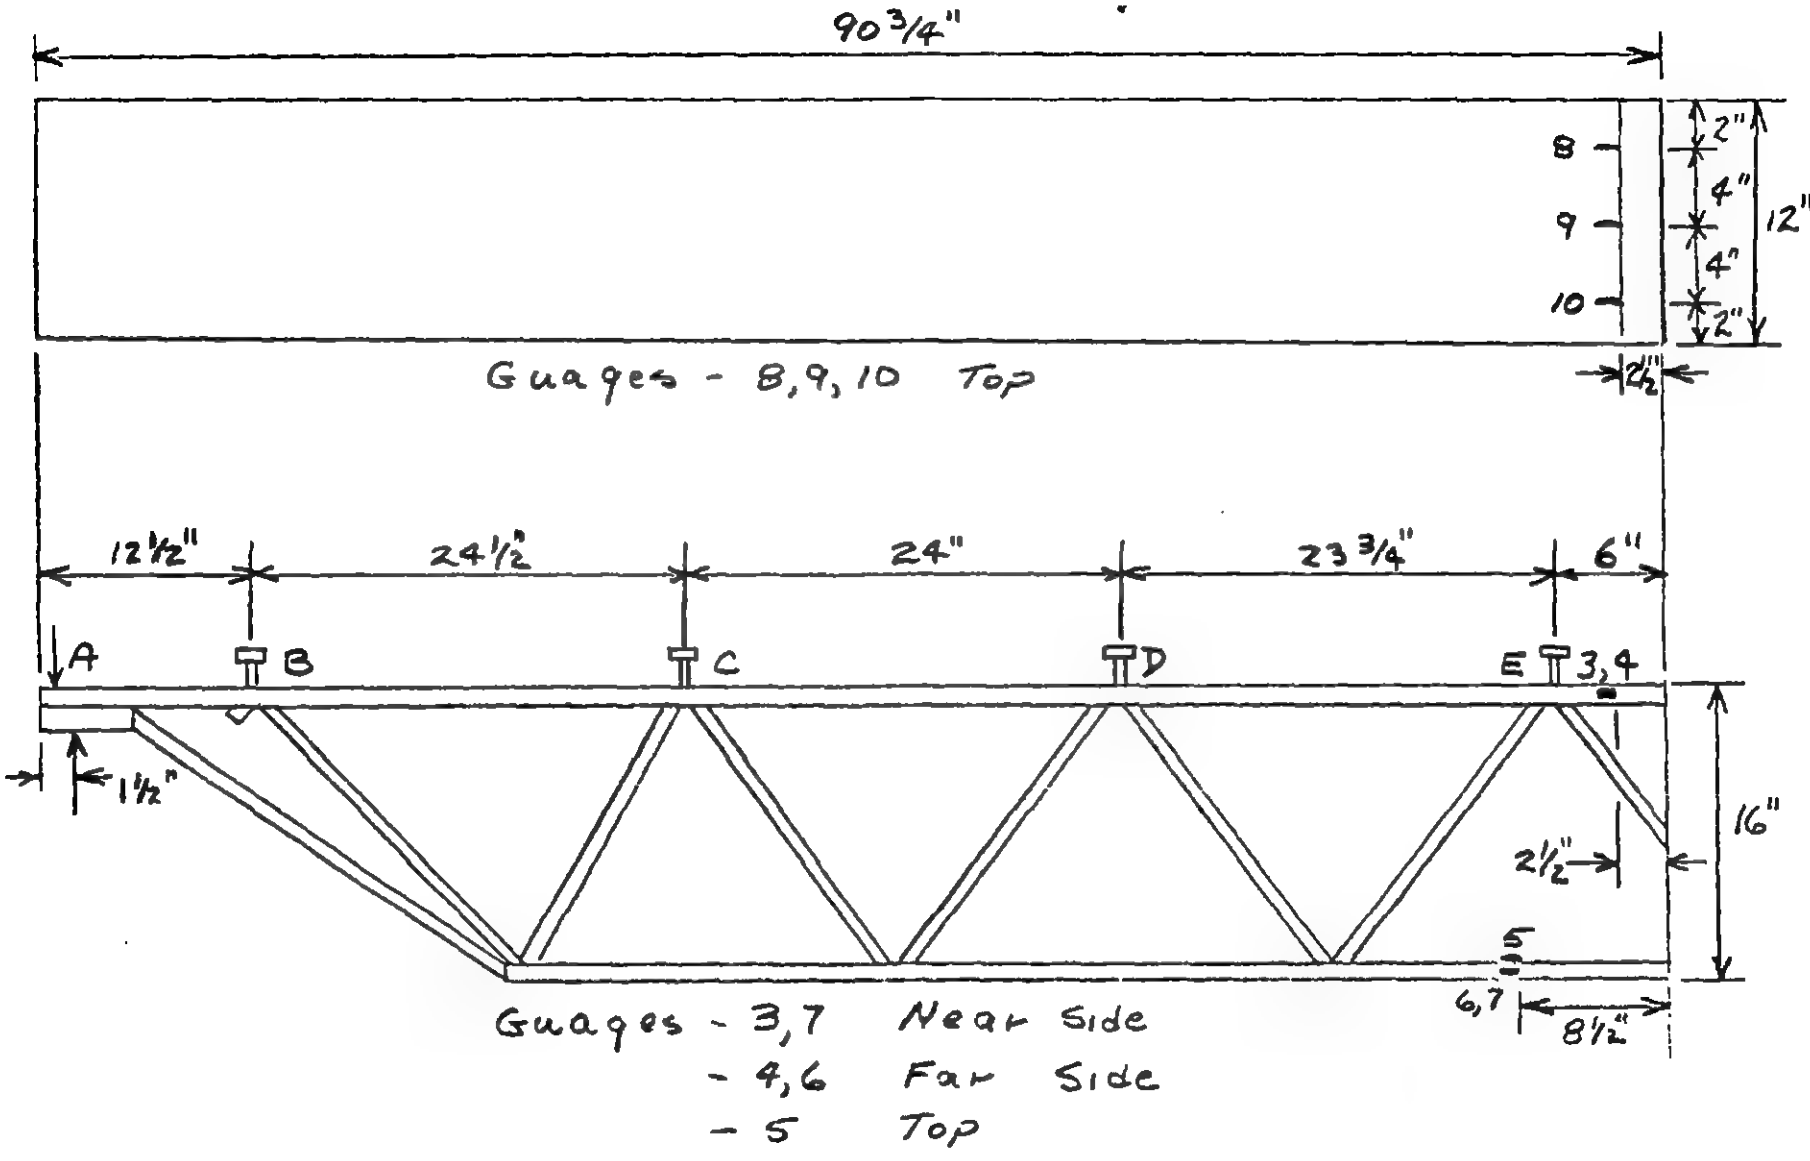
Fig. 3c Test Joist C4

4.1.3 _C4 - With only a couple of load increments applied the slab at the first shear connector cracked nearly to the top due to the large rotation. As the next load increments were applied a separation occurred between the compression chord and the slab from the first to third shear connectors. With the next load increment the tension chord failed where it was welded to the connecting bolt.

The failure was due to the untimely failure of the tension chord connection.

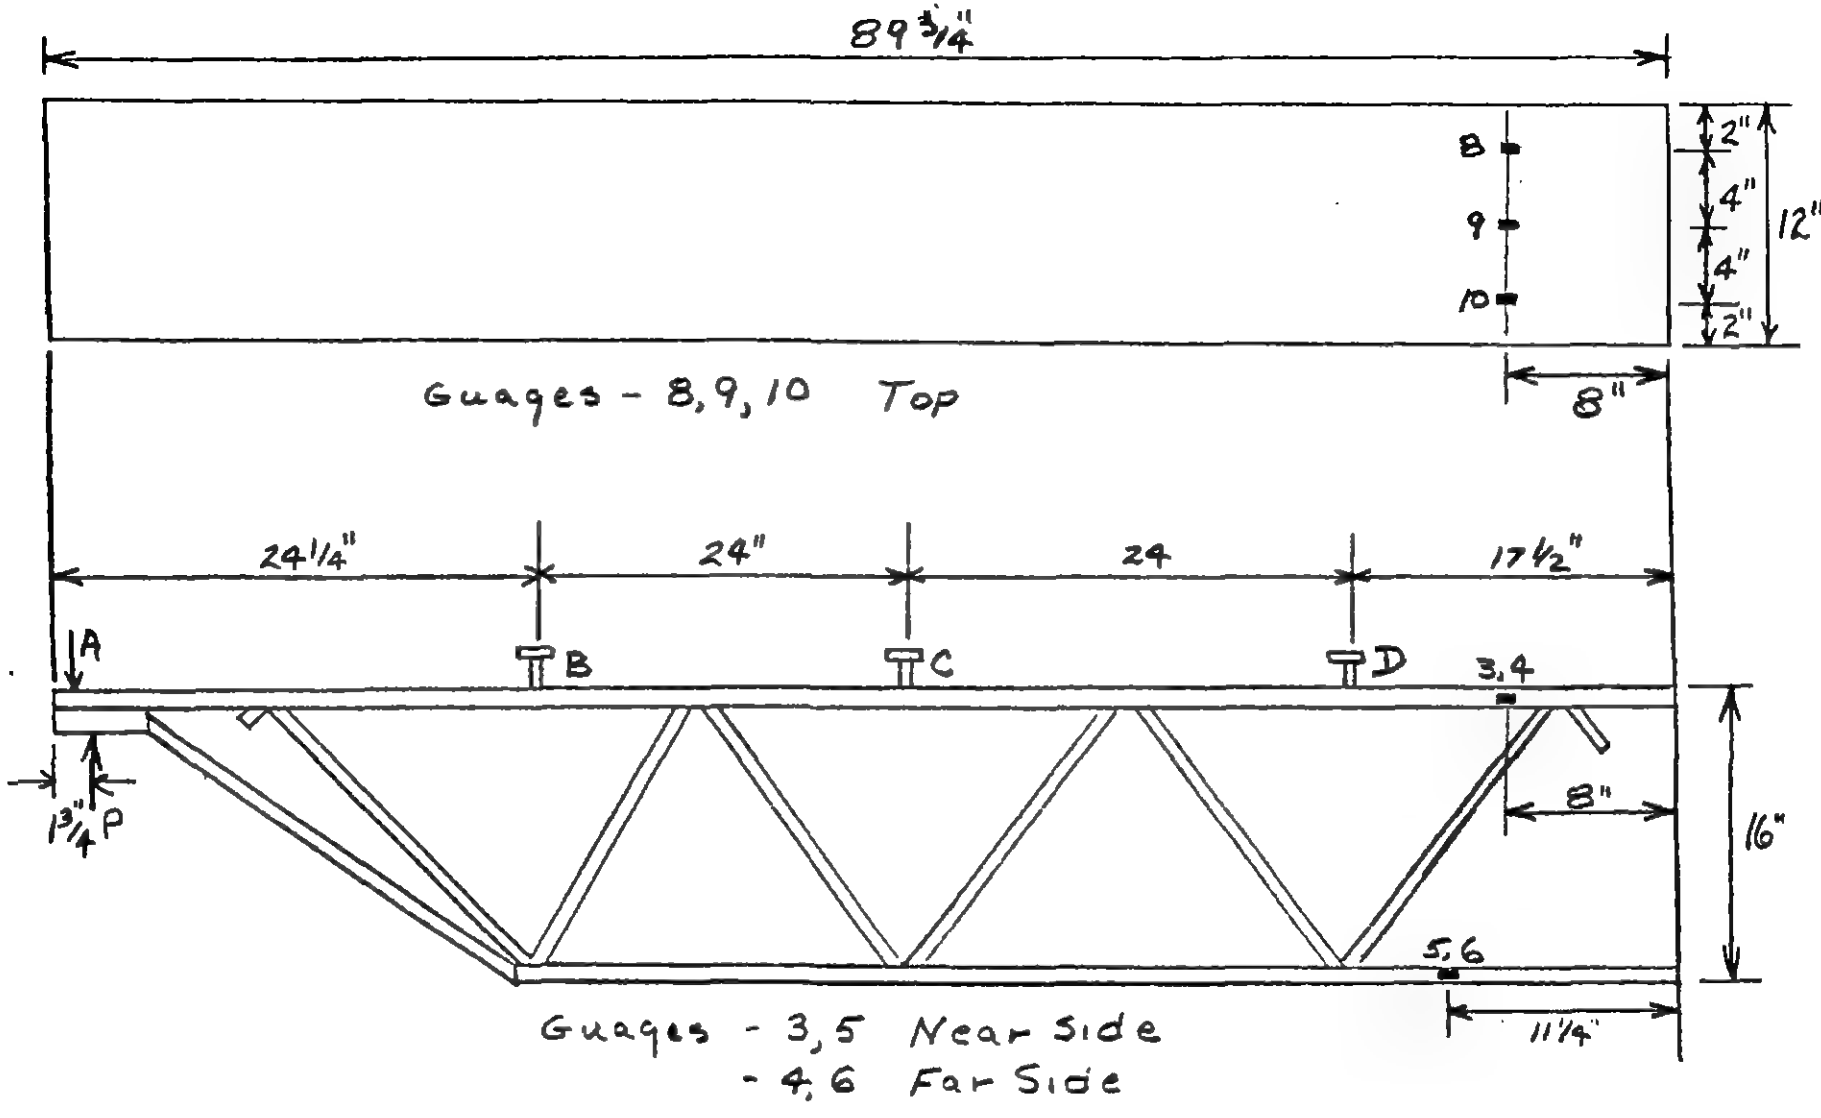
FIG. 3d Test Joist C7

4.1.4 _C7 - The load was applied and increased until the tension chord yielded at which time the slab at the last shear connector cracked to mid-depth. As the load was increased beyond this point a loud report was heard. Later inspection revealed that the first and second shear connectors had failed. More load was applied until the compression chord buckled.

The failure was attributed to the yielding of the tension chord, followed by the fracture of the two shear connectors and then the buckling of the compression chord.

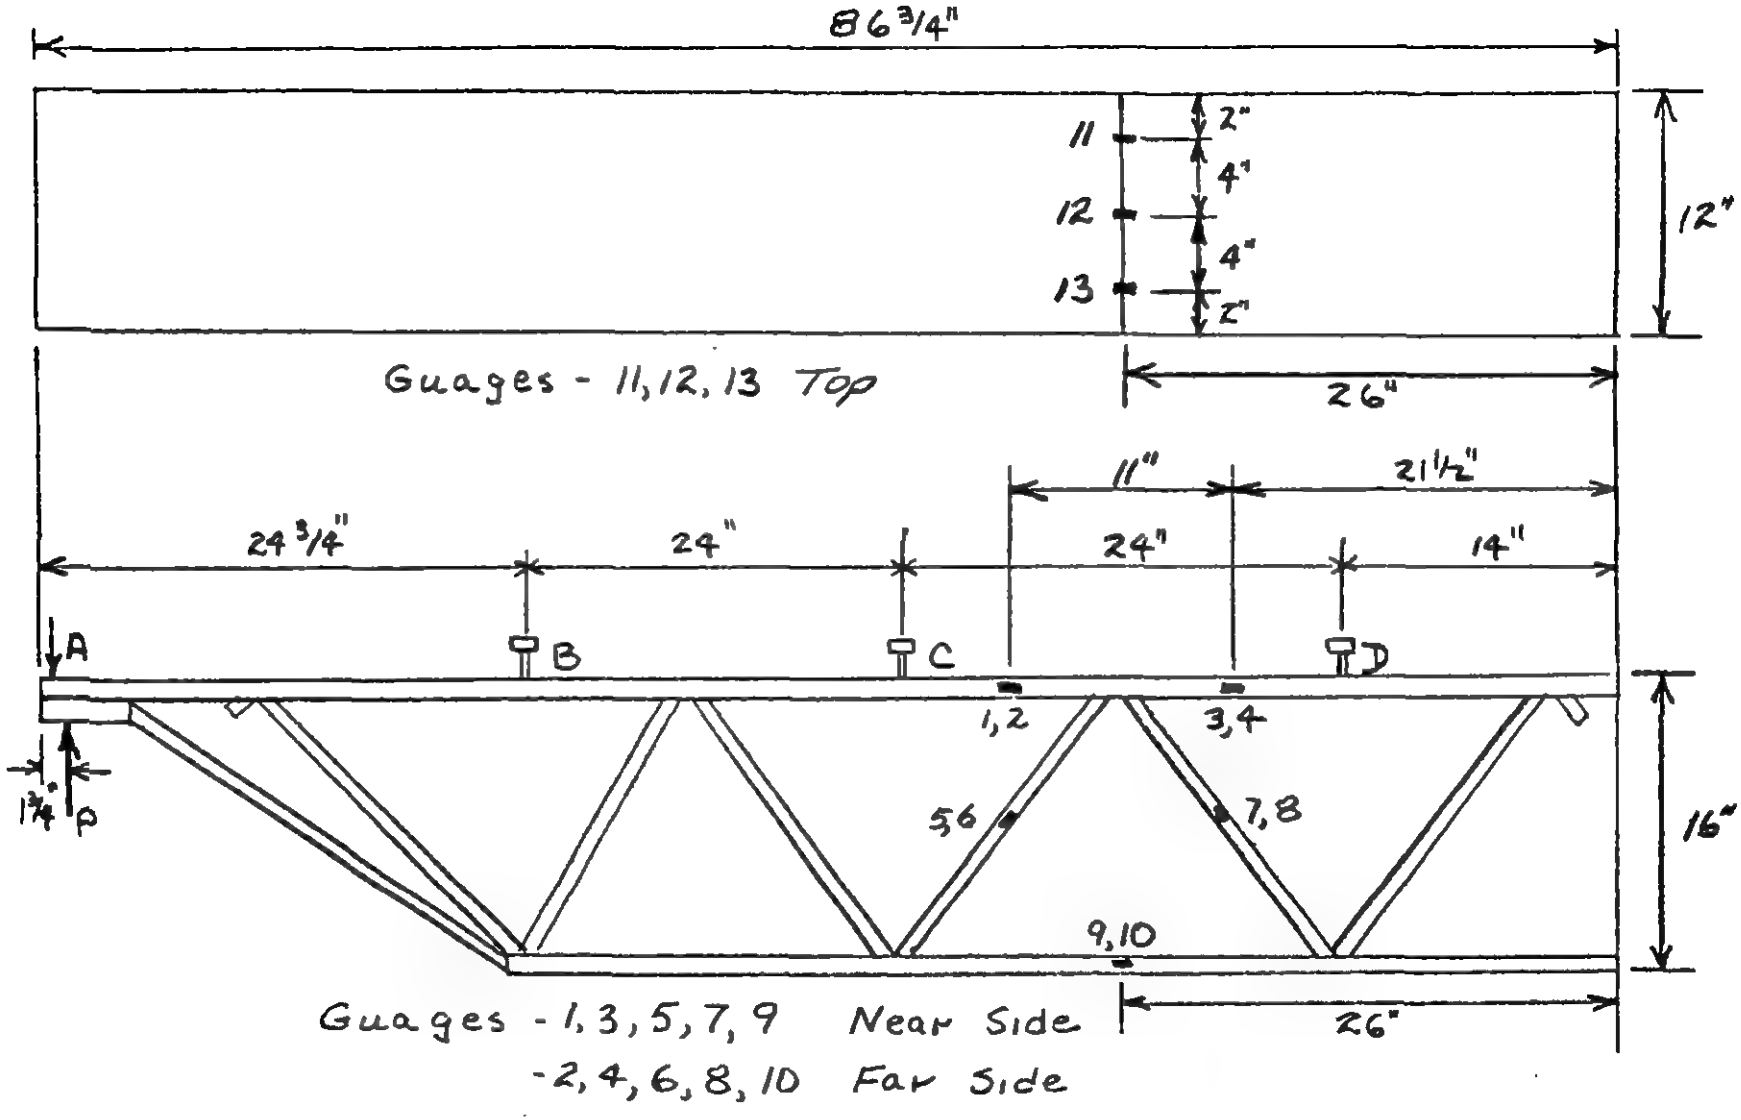
FIG 3e Test Joist C8a

4.1.5 _C8a - After the load had reached near the value causing yielding in the tension chord a crack at the first shear connector had developed a considerable way into the slab. The tension chord connection then failed. The load was removed, the tension connection was then repaired.

The load was applied until again near the yield point of the tension chord. A tension crack in the slab developed at the third shear connector. The application of load was continued until the tension chord again failed in the vicinity of the connection weld.

The failure was due to the fracture of the weld connection of the tension chord.

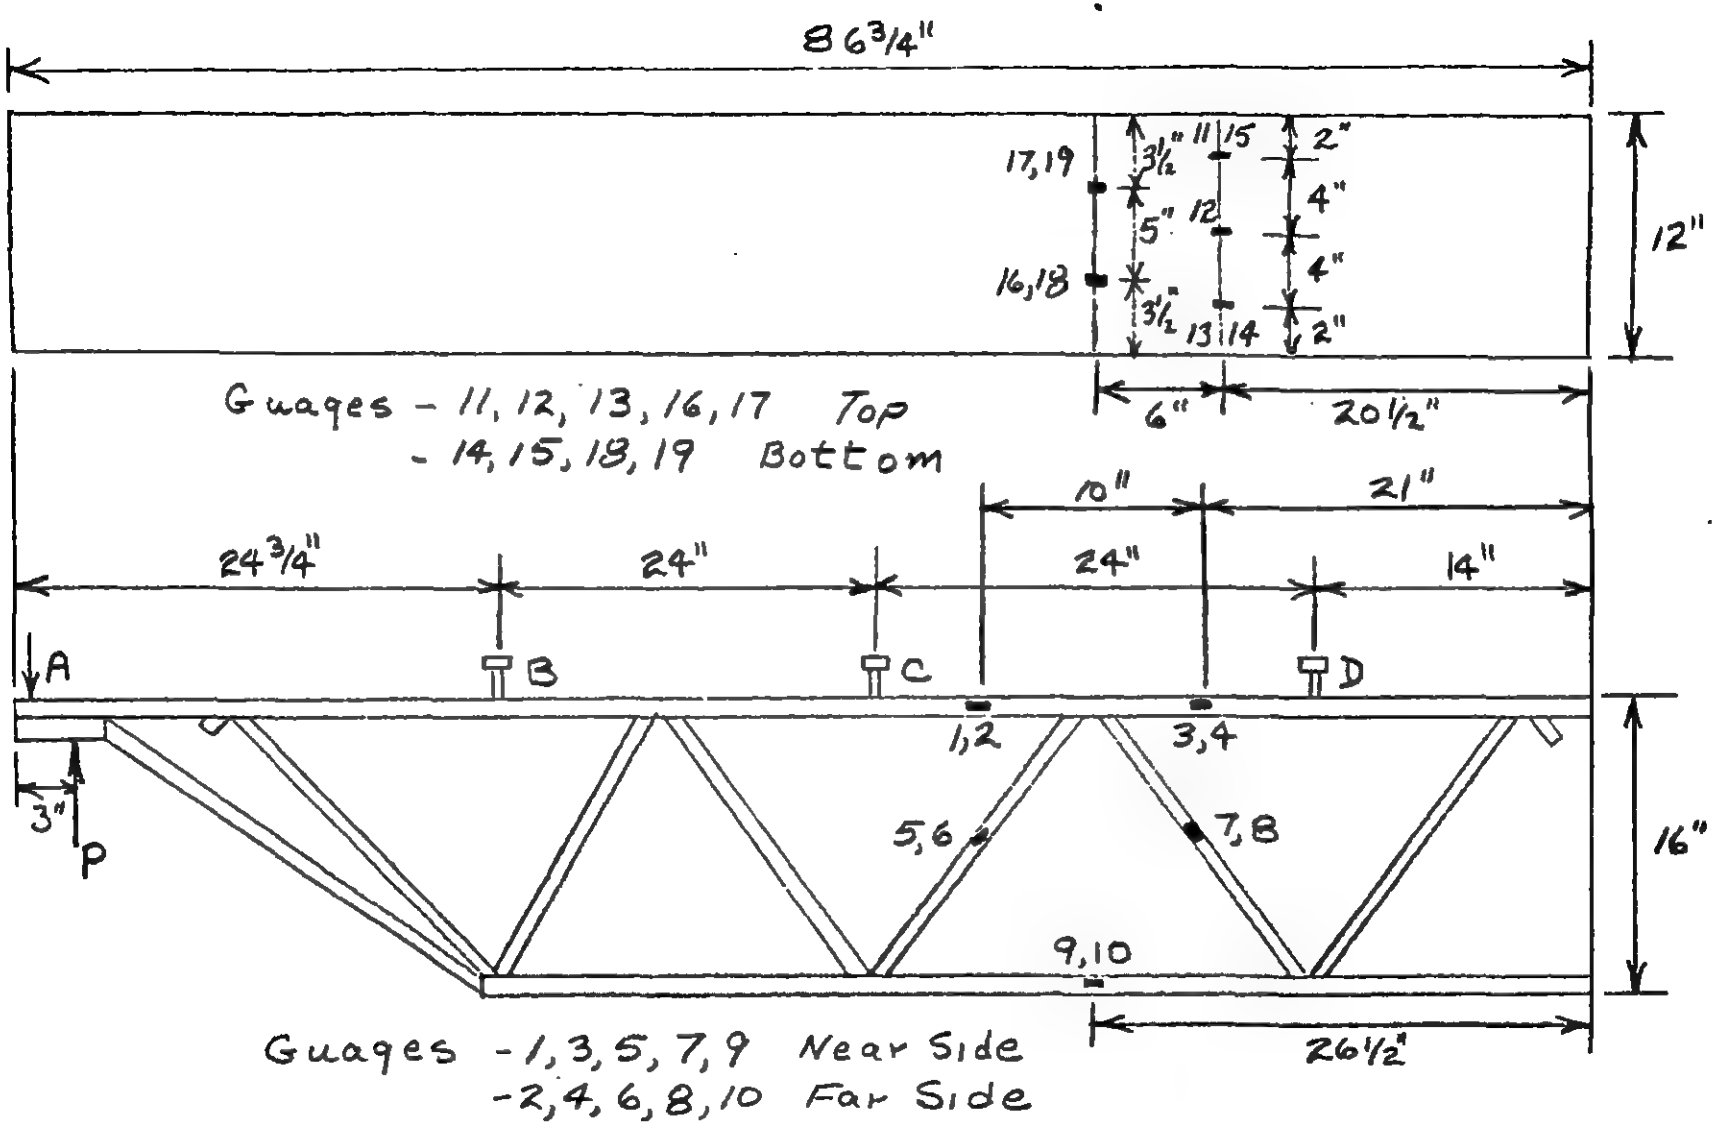
FIG 3f Test Joist C8b

4.1.6 C8b - The load was incremented for some time before the first tension crack was observed at the first shear connector. The load was increased until cracks also developed at the third shear connector. This maximum load was then held for some time while the deflection increased. Finally the tension connection failed.

The failure was a result of the fracture of the tension chord connection.

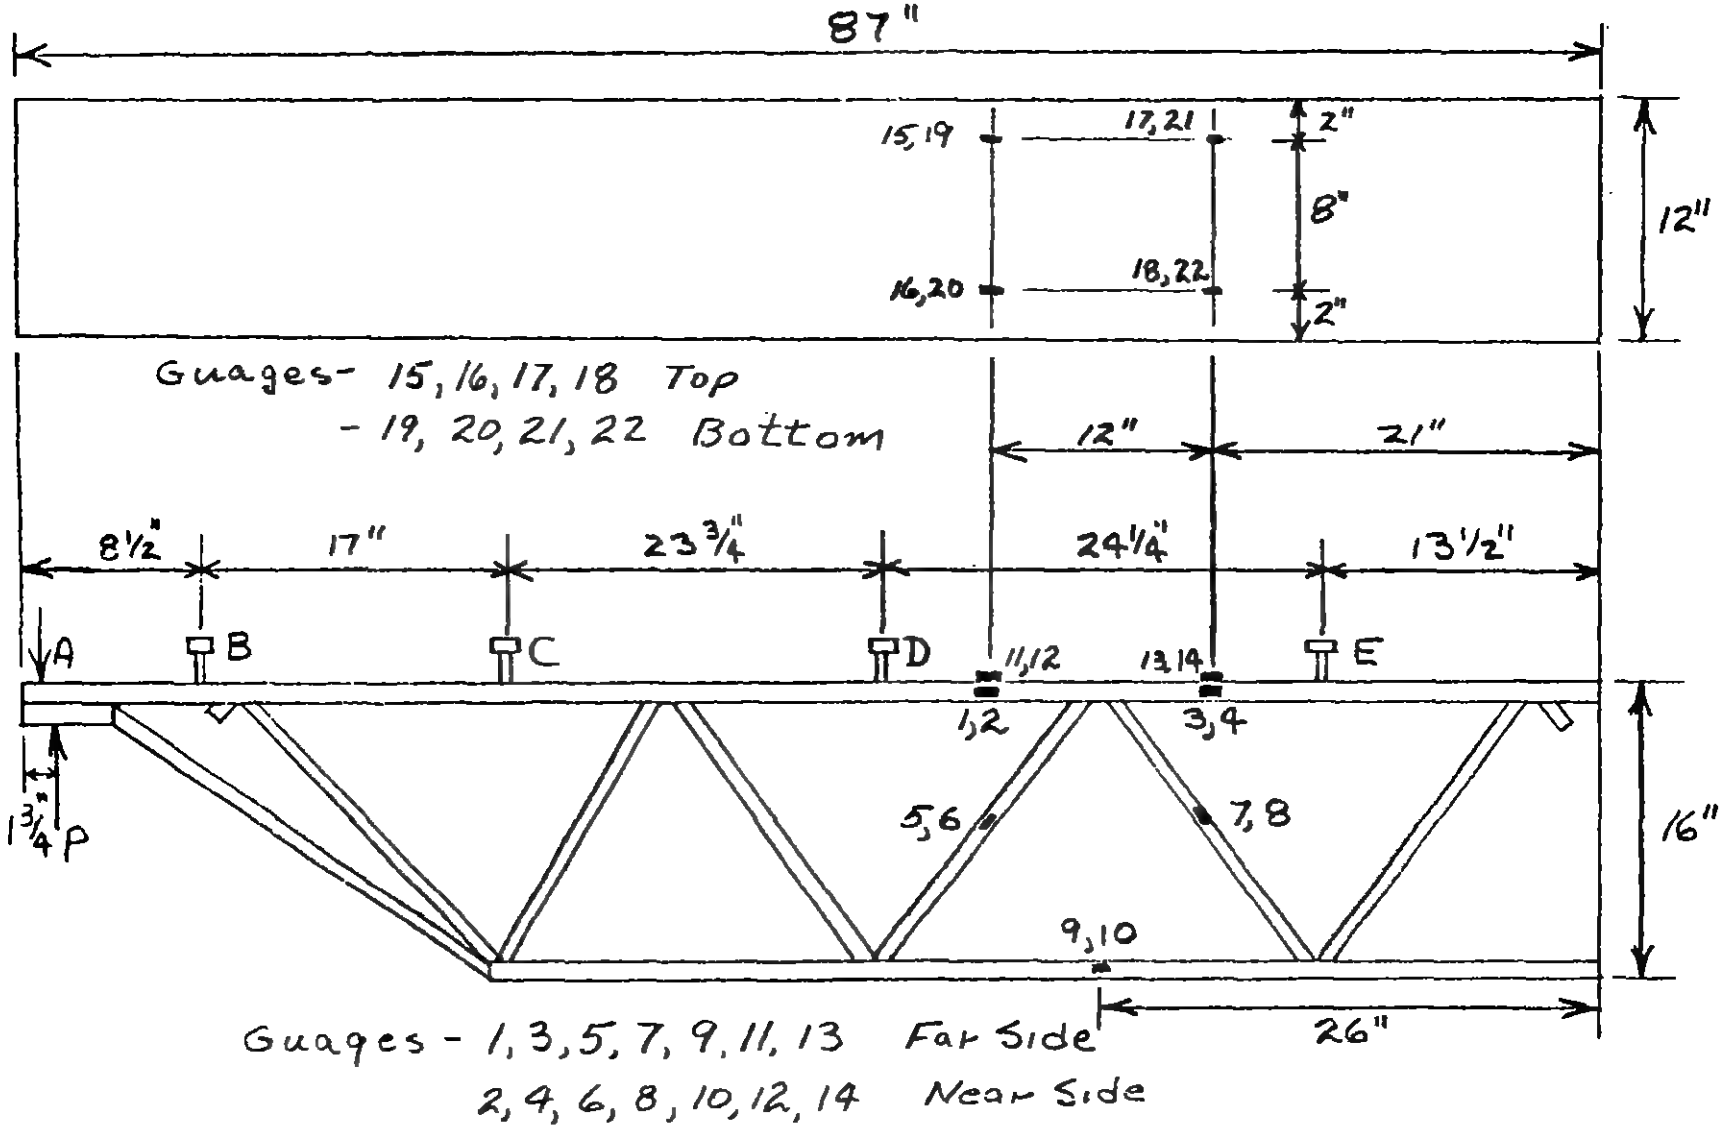
FIG 3g - Test Joist C9

4.1.7. C9 - After several load increments were applied a slight separation of the compression chord from the slab was noted. Additional loading resulted in the fracture of the tension chord. The load was removed and the tension chord was repaired.

The load was again applied until the stress in the tension chord was near the yield point at which time a load report was heard. Later investigation revealed that three of the four shear connectors had fractured. Additional load increments were applied until the compression chord buckled.

The failure was attributed to the fracture of the shear connectors followed by the buckling of the compression chord.

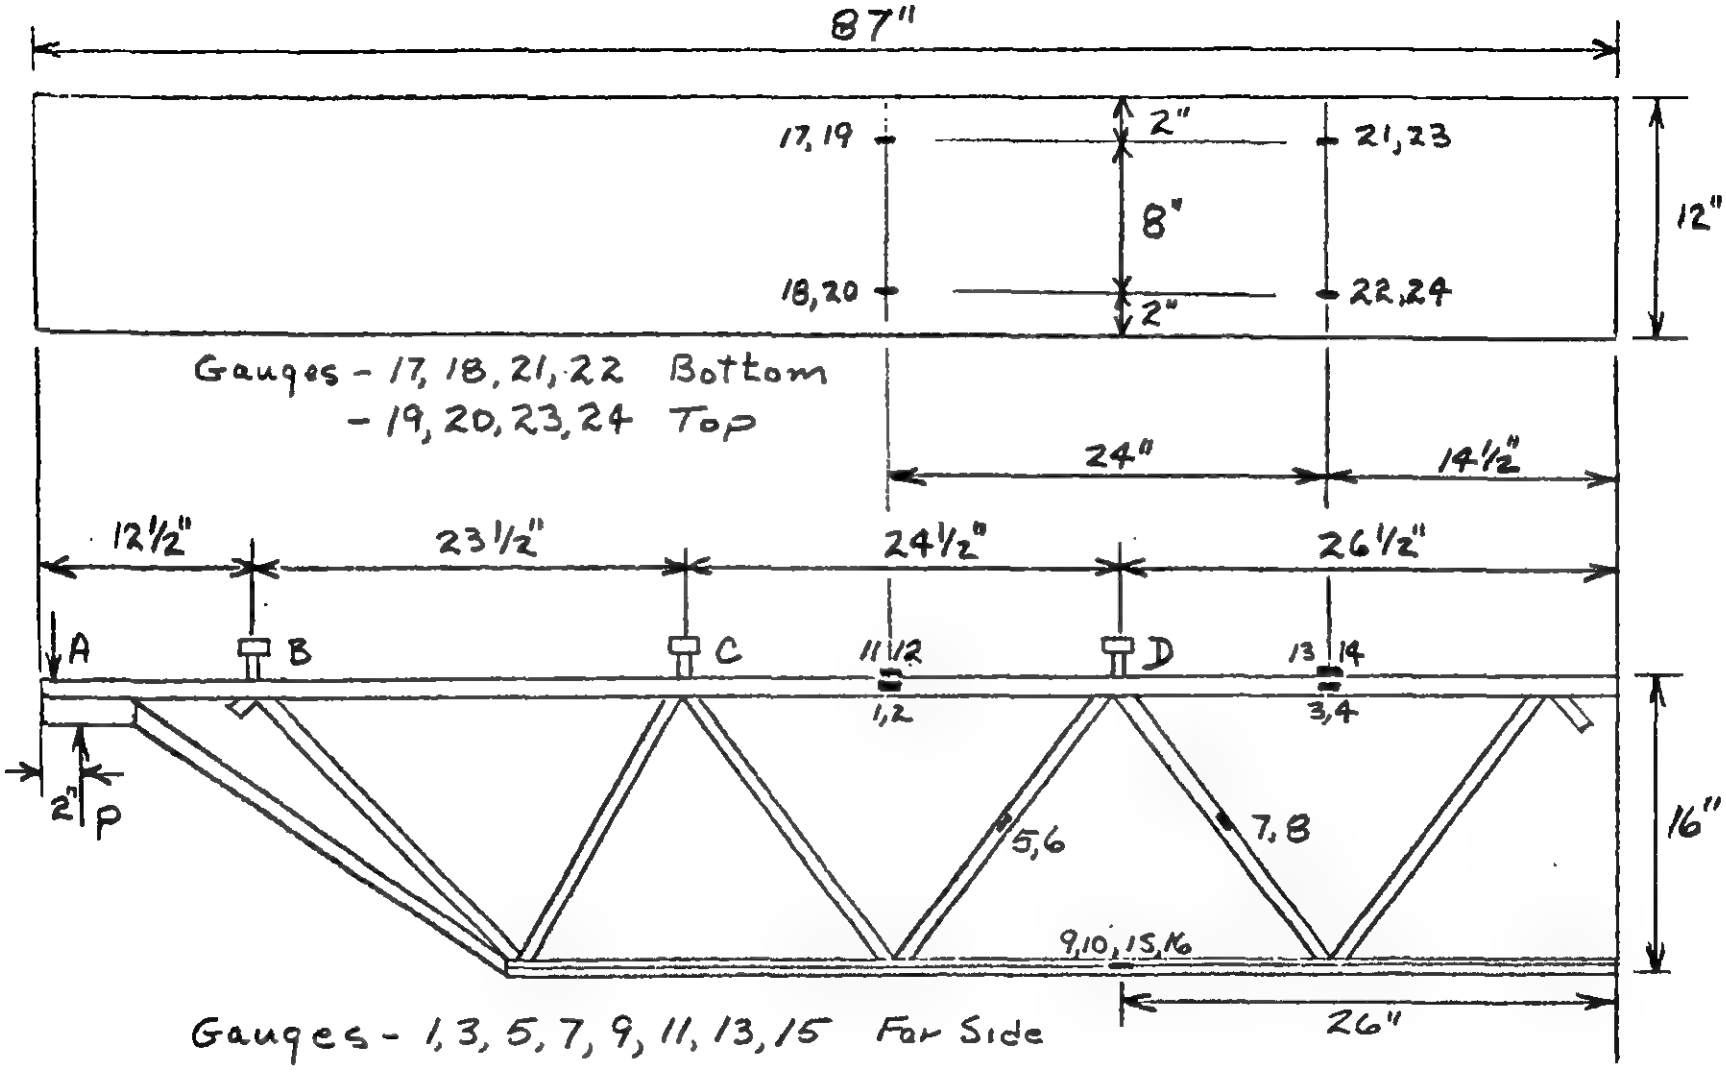
FIG 3 h - Test Joist C10

4.1.8 C10 - The load was applied in increments until considerable separation was noted between the compression chord and the slab. This occurred between the last shear connector and the support point of the cantilever. A tensile crack also appeared in the concrete at the first shear connector. Addition load increments resulted in the slab separation increasing considerably and the tensile crack extending almost to the top of the slab. The next load increments resulted in the buckling of the compression chord and the fracture of the shear connectors.

The failure of this cantilever was attributed to the buckling of the compression chord and then the fracture of the shear connectors.

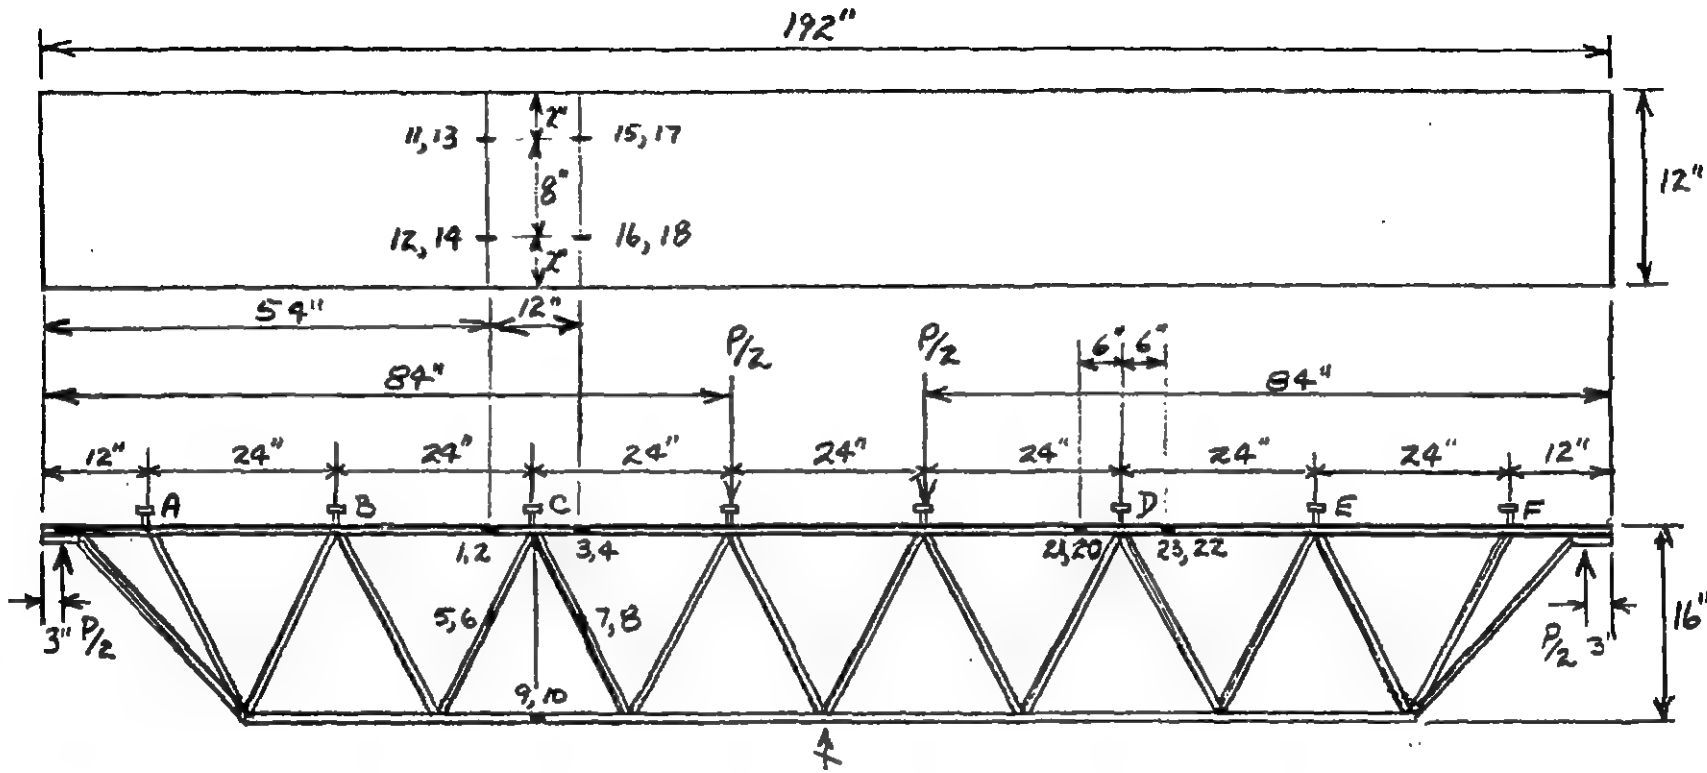
FIG 3 i Test Joist B1

4.2.1 B1 - The application of load was done in increments at which time readings and observations were made. The first cracks in the concrete slab occurred at the load points at a fairly high load. Increasing the load slightly caused a considerable separation of the slab from the compression chord in the vicinity of the second shear connector from the left. With additional load a loud report was heard and the left compression chord buckled laterally about one inch. The three shear connectors failed at the same time.

Failure was caused by the buckling of the compression chord followed by the fracture of the shear connectors.

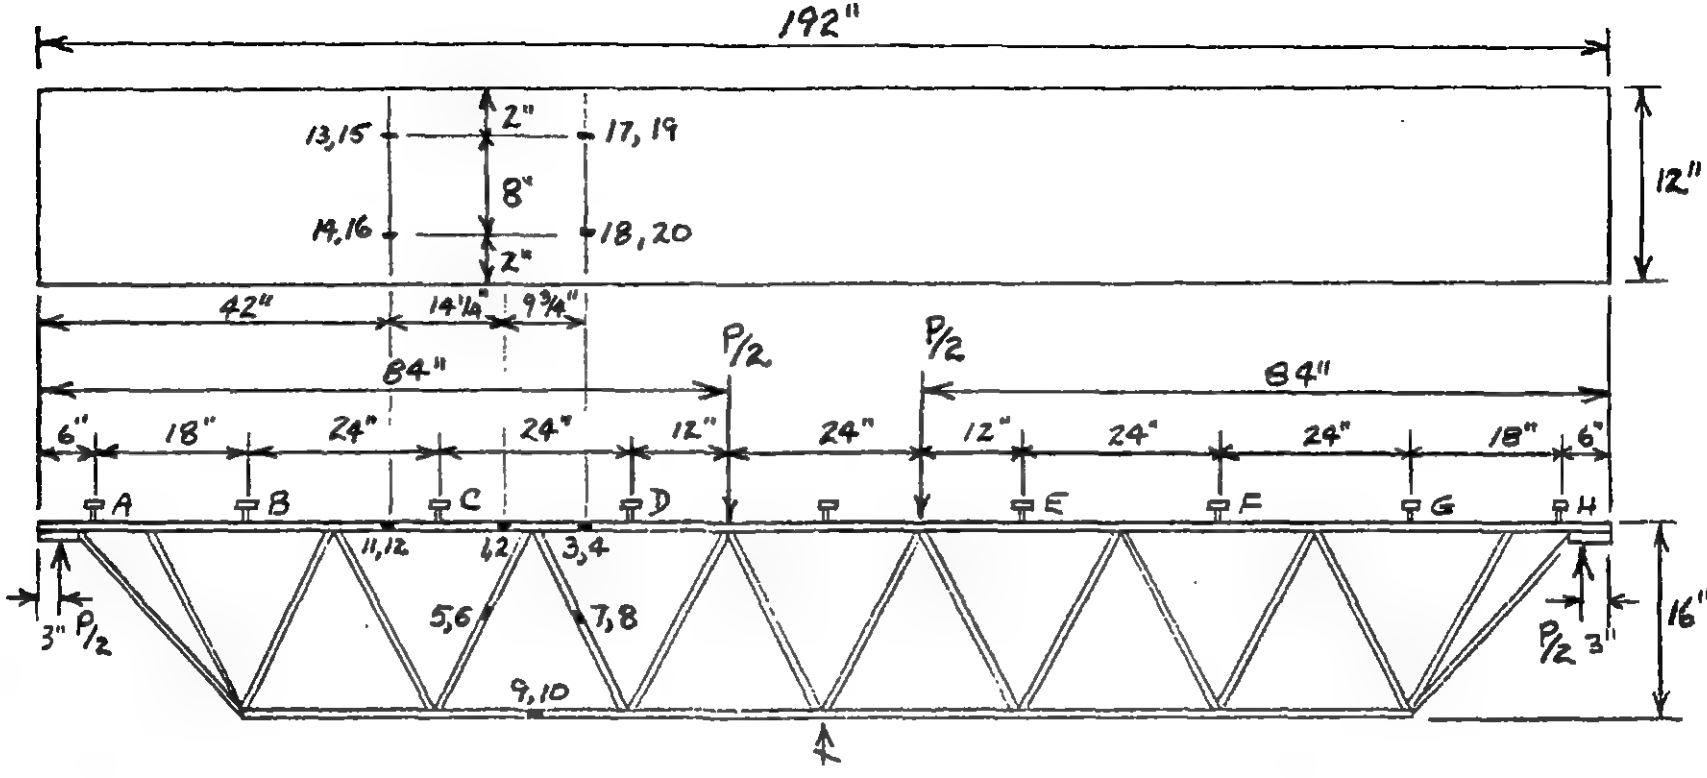
FIG 3j Test Joist B2

4.2.2 B2 - The load was applied in increments until nearly the maximum value was obtained before any cracks were observed. The cracks occurred in each span at the load points and at each shear connector closest to the load points. With the application of the next load increment a loud report was heard. Examination of the beam indicated considerable separation at the last shear connector in the right span. On attempting to increase the load the compression chord at this last shear, buckled vertically.

The failure was due to the compression chord buckling followed by the fracture of the shear connector.

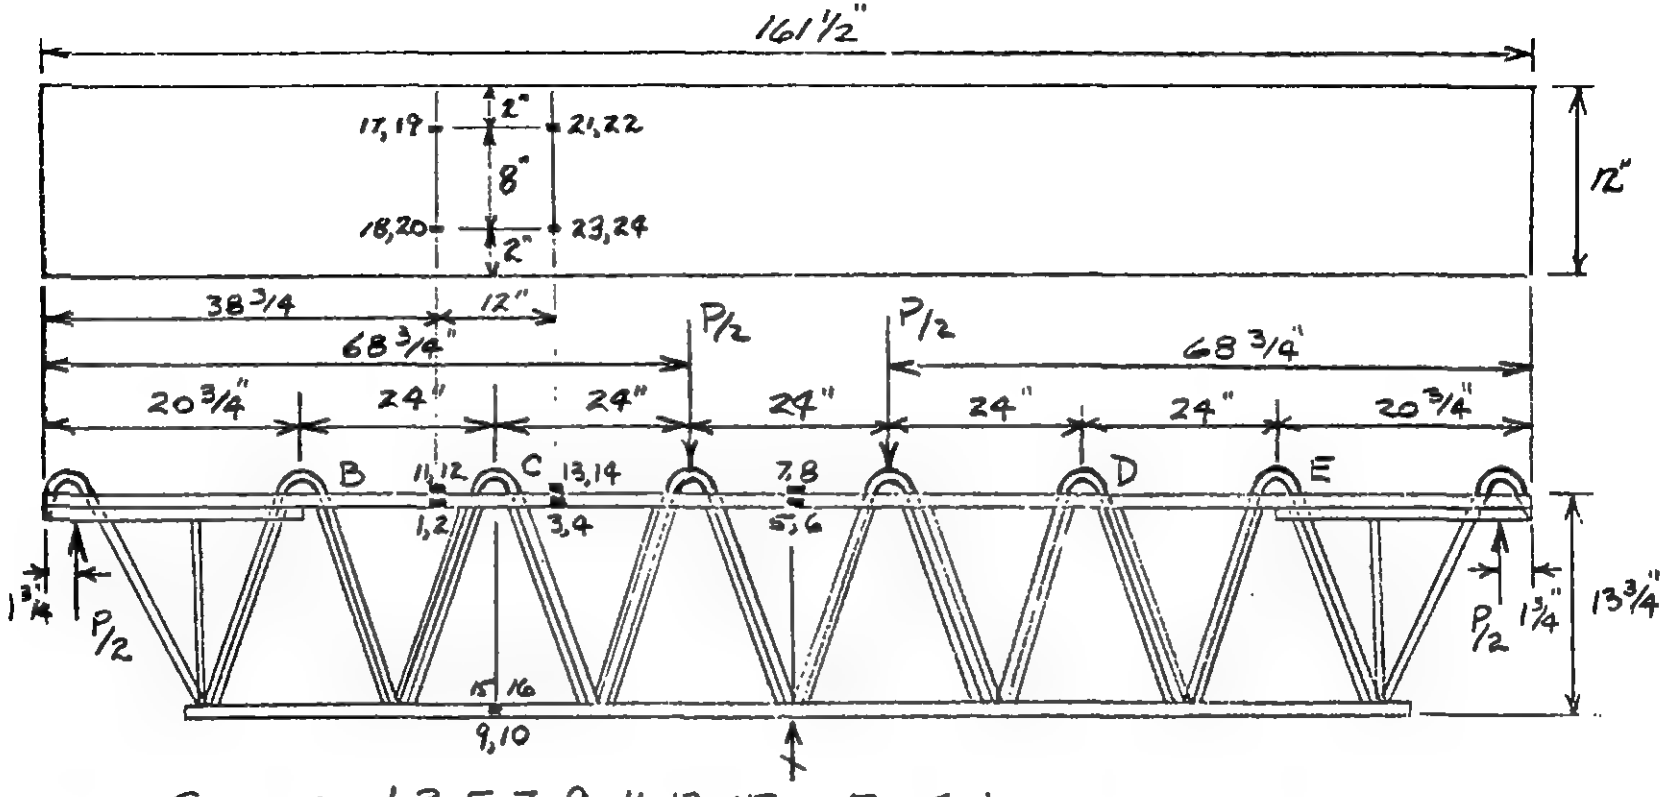
FIG 3 k Test Joist B3

4.2.3 B3 - The load was applied in increments until half way to the maximum load before a slight separation of the compression chord and slab occurred. Additional loading increased the amount of separation until, at

the second extended web in the right span, cracks appeared in the concrete. At this time cracks also appeared around the third extended web of the right span. As the load was again increased the cracks around the second and third extended webs developed into general crushing of the concrete and finally with a loud report the compression chord at the third connector began to buckle. The extended webs then pulled out of the concrete.

The failure was attributed to the crushing of the concrete around the extended webs followed by the buckling of the compression chord.

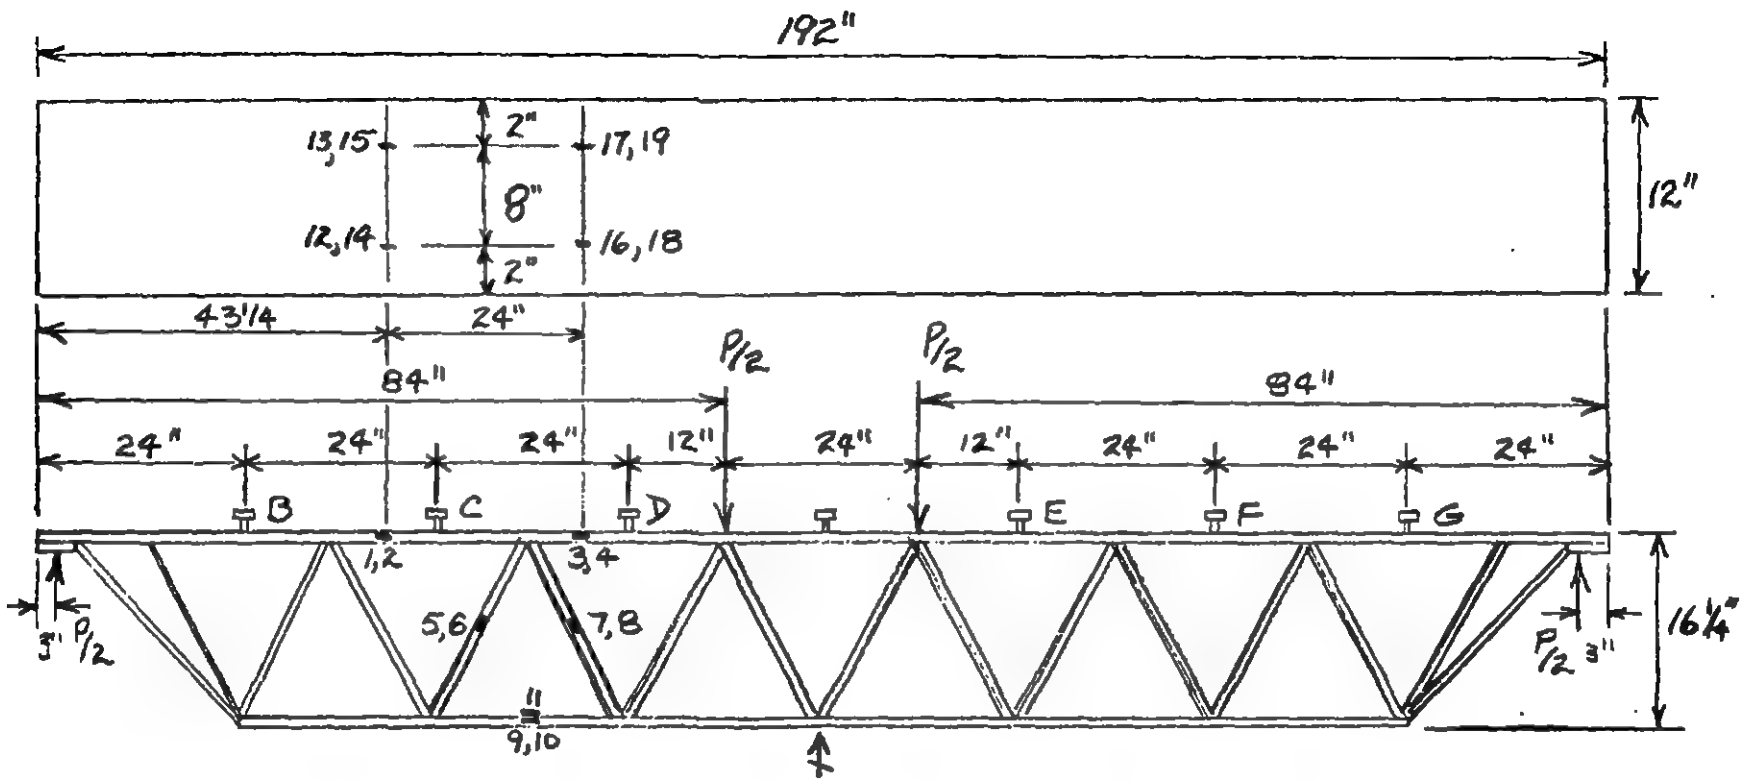
FIG 3 ℓ Test Joist B4

4.2.4 B4 - The first cracks appeared in the concrete at the location of the first shear connector in each span after only a small load. Additional load resulted in cracks at the second shear connector and load point of each span. When more load increments were applied it became difficult to hold the load steady and then the first compression web member in the left span buckled.

The failure was caused by the buckling of the first compression web member in the left span.
